**THE GOVERNMENT OF THE REPUBLIC OF MALAWI
MINISTRY OF AGRICULTURE, IRRIGATION AND WATER
DEVELOPMENT**

**IRRIGATION, RURAL LIVELIHOOD
AND
AGRICULTURE DEVELOPMENT PROJECT**

**KAPICHIRA DAM AND SHIRE VALLEY IRRIGATION PROJECT
VISIT REPORT BY PANEL OF EXPERTS**

Jan 31, 2017

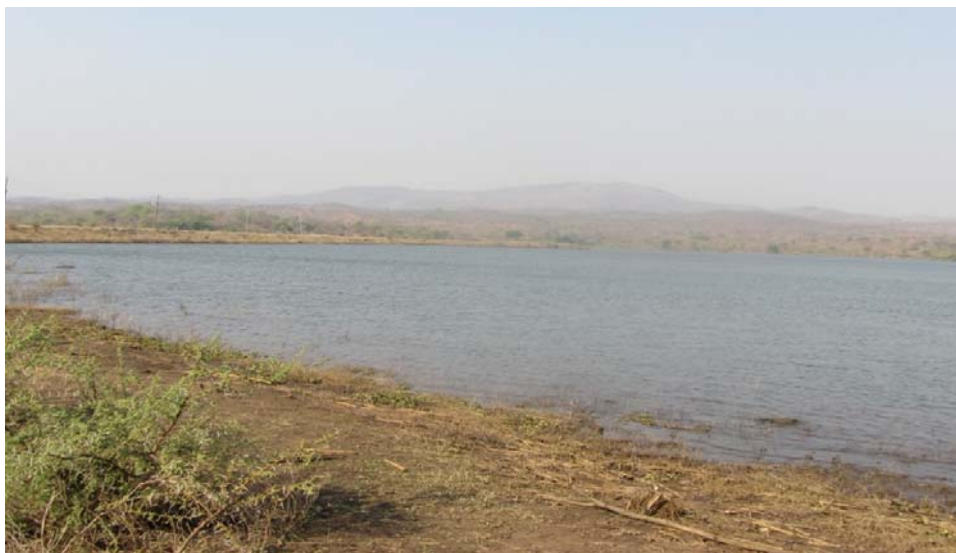
Upstream spur viewed from close to proposed intake site.

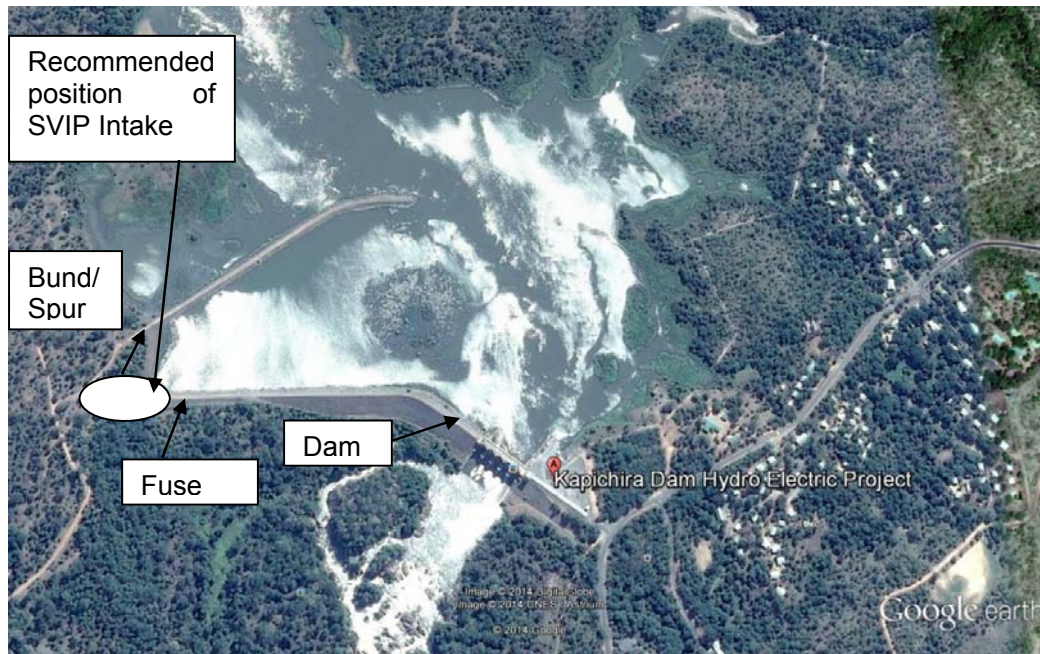
Figure 6.1: Recommended position of SVIP Intake

The location of SVIP indicate as determined by hydraulic modelling is shown on Figure 6.1.

During the meeting of Jan 27 EGENCO expressed concern on the proposed location of SVIP intake on the downstream side of the dyke. Their concern is that it may lead to parallel flows along the dam and may result in damage to the rip rap as happened in 2004.

It is recommended that SVIP and EGENCO management discuss EGENCO's concerns and try to answer the EGENCO's concerns, which can probably be further alleviated by construction of a dyke on the left side of the approach channel of the intake of SVIP more or less parallel to the existing dyke. The location and length of this dyke could be optimised on the hydraulic model, which should clearly demonstrate that the proposed location of the SVIP intake will not result in flows parallel to the dam.

In view of the above POE recommend another run of the ARTELIA model incorporating a dyke running approximately parallel to the spur dyke from the left hand side of the intake.

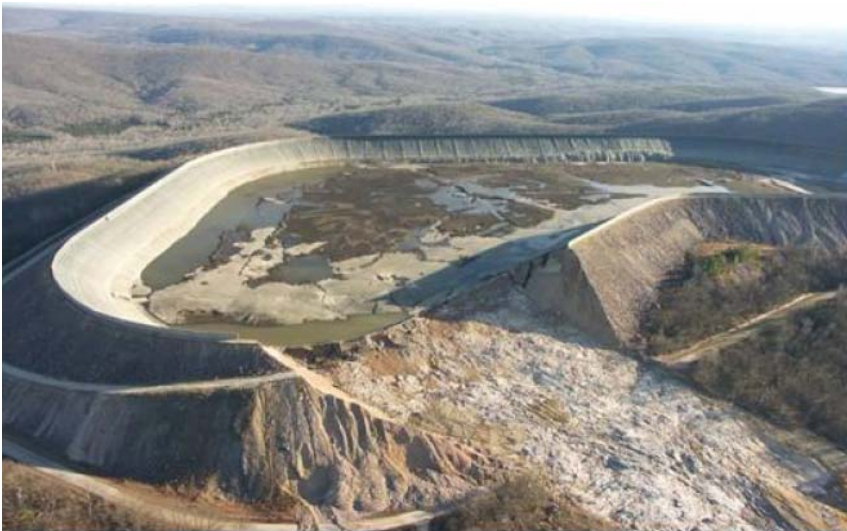
Figure 8.1. Taum Sauk Dam after failure.

POE recommends that the requirements for freeboard should be reviewed and, if necessary, increased. It should be borne in mind that incorrect settings of the high level cutouts and inadequate freeboard were amongst the causes of the failure of the upper reservoir for the Taum Sauk pumped storage scheme in the USA.

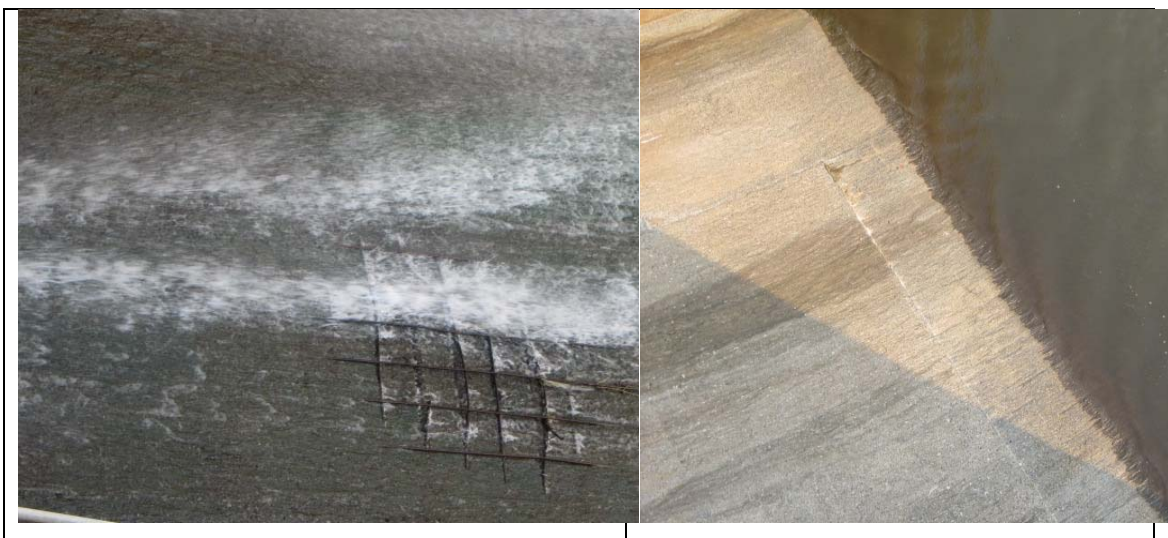
4. The concrete erosion on the Spillway chute (as reported in the POE second visit Report) has been present for quite some time and has mainly occurred due to less cover over the temperature reinforcement and has not been repaired so far. EGENCO has been monitoring the same for years for remedial action, if the wear is considered to reach levels that would affect the functional requirements of the chute.

POE Observations: Moderate erosion of the concrete surfaces have probably developed into the larger erosions as pointed out in the second visit of the POE. The erosions need to be properly repaired as these have potential to enlarge during long operation of the affected bays.

Cracks are observed on Chute of Bay No 3. Some concrete near the toe has been washed away.

The bottom seals of most of the gates are not effective and leakage is taking place.

The above described conditions are shown in the photographs in Figures 1 and 2

Figure 1 Exposed Reinforcement bay 4 and leakage	Figure 2 Washed out concrete in bay 3
--	---------------------------------------

The damages on the concrete chute should be repaired as per recommendation of a qualified civil engineer.
