THE GOVERNMENT OF THE REPUBLIC OF MALAWI
MINISTRY OF AGRICULTURE, IRRIGATION AND WATER
DEVELOPMENT
KAPICHIRA DAM AND SHIRE VALLEY IRRIGATION
PROJECT

VISIT REPORT BY PANEL OF EXPERTS

REPORT ON VISIT TO KAPICHIRA DAM

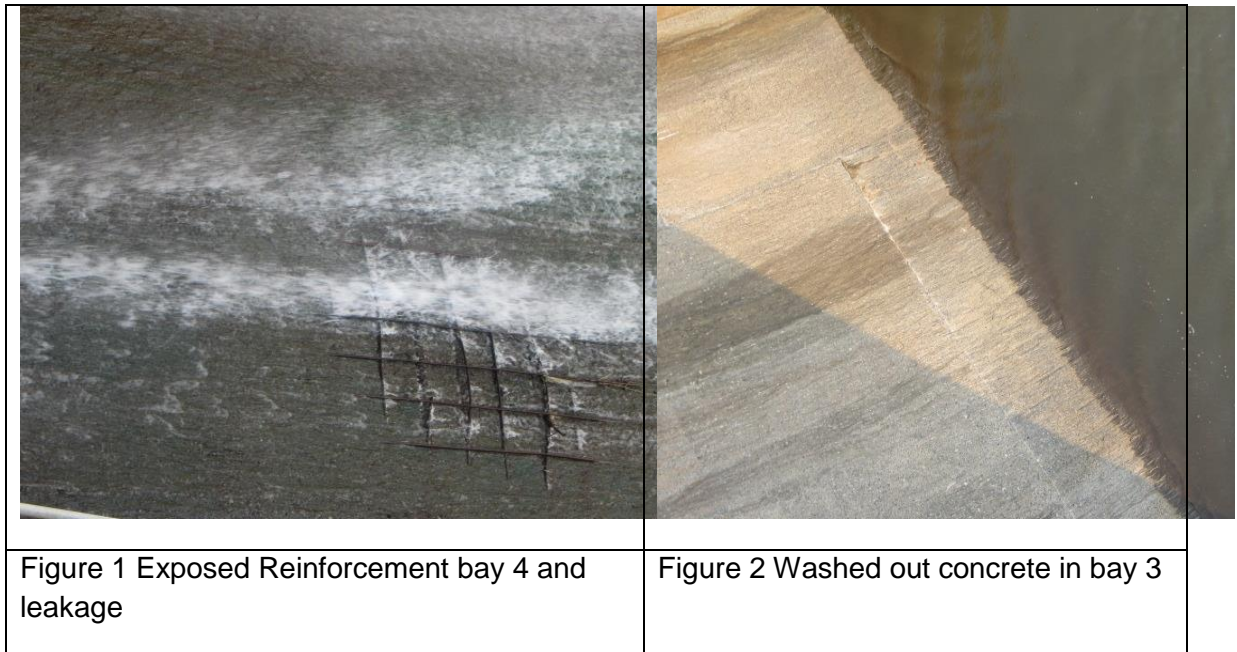
1. The sloping chute of Bay 1 shows normal wear and tear.
2. Cracks are observed on chute of Bay 2.
3. Cracks are observed on Chute of Bay No 3. Some concrete near the toe has been washed away.
4. In Bay No. 4 reinforcement is exposed in one block.
5. The bottom seals of most of the gates are not effective and leakage is taking place.

The above described conditions are shown in the photographs in Figures 1 and 2

- The damages on the concrete chute should be repaired as per recommendation of a qualified civil engineer. This should be done within a year of the date of this report.
