**SHIRE VALLEY IRRIGATION PROJECT**  
**Geotechnical Investigation Report**  
**(FINAL)**

Technical Feasibility Study  
on Shire Valley Irrigation Project

**November 2016**

**KOREA RURAL COMMUNITY CORPORATION**  
in Joint Venture with  
**DASAN CONSULTANTS CO., LTD.,**  
**GK WORKS CIVIL AND STRUCTURAL ENGINEER**

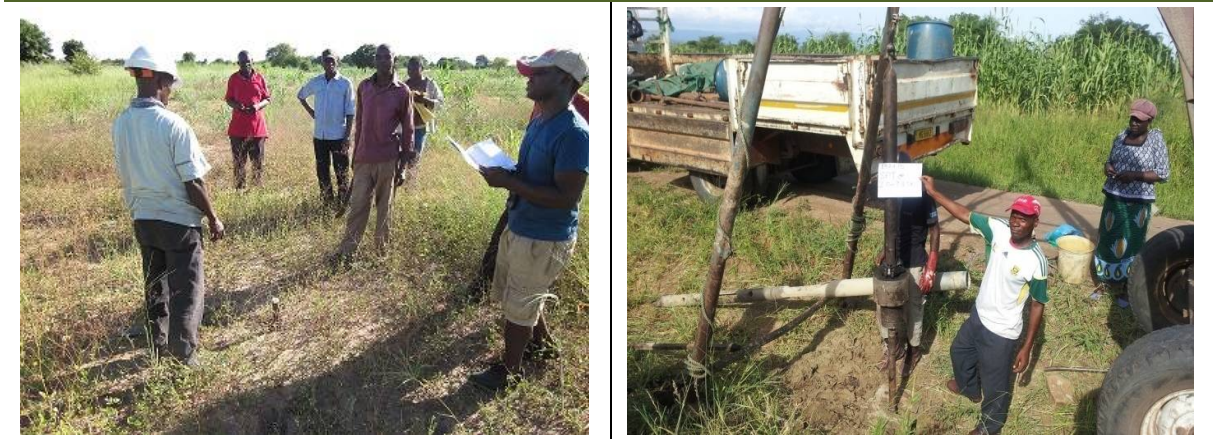
**[Figure 2.1] Drilling Point Check(left) and Percussive Drilling & Standard Penetration Test(right)**

Each site for geotechnical investigation was checked through the reconnaissance survey for ease of accessibility with regard to the geotechnical investigation equipment. And as stated in the preceding discussion, the investigations were conducted using percussive drilling or auger boring.

The geotechnical investigations and laboratory test were done in accordance with the Malawi's recommended standards. Standard penetration test (SPT) was carried out in boreholes at intervals of 1.5m. In addition to SPT, samples were collected from boreholes at intervals of 1.5m for laboratory testing.

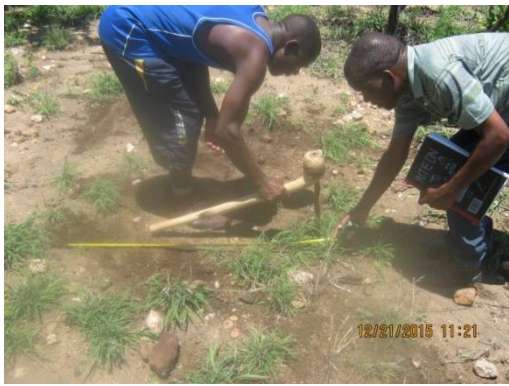
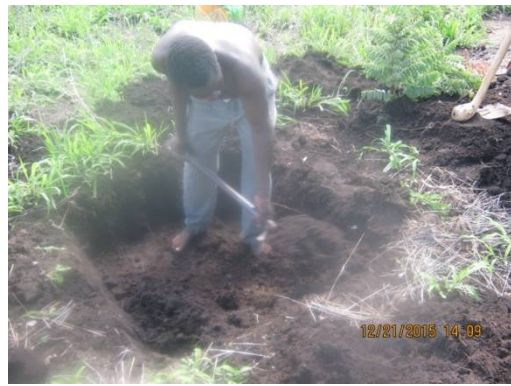
[Figure 2.2] Measuring the Surface Dimension of the Pit (left) and Digging the Pit (right)

- (a) Excavation of the soil layer which was to be assessed for percolation rate by digging a pit measuring 1m by 1m and by 0.5m depth. All the loose material was then removed from the sides and bottom of the pit (Figure 2.2);

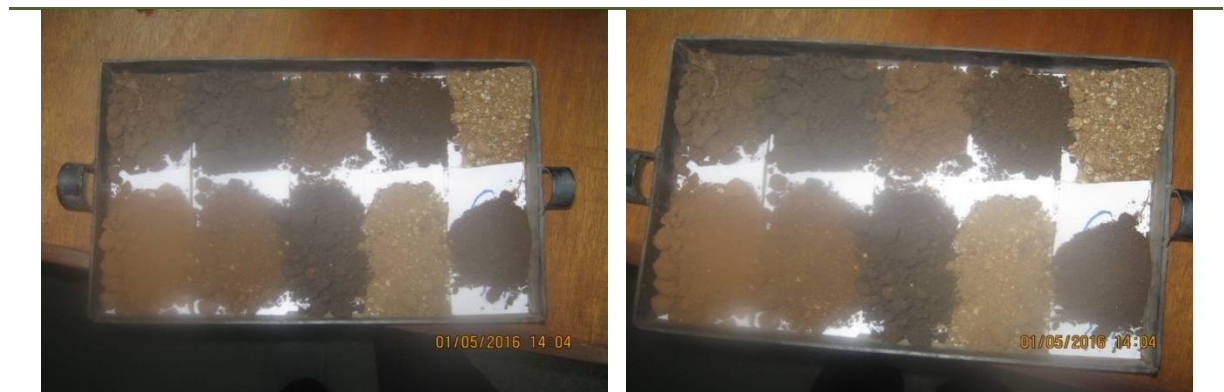
**[Figure 2.8] Soil Samples Collected from the 10 Points on the Feeder Canal**

It is clear from the description of the soil profiles that the soils along the Main canal 1 are generally sandy in nature comprising clays and humus. As such, conveyance losses due to seepage expected to take place, therefore in this point of view lining of canal is recommended. Especially inside Majete area, the lined Main canal 1 is highly recommended to minimize the seepage loss. In this regard a buried concrete siphon could be considered as another option. During the preliminary design the pros and cons of the two alternatives shall be carefully assessed, and selected the more advantageous one.

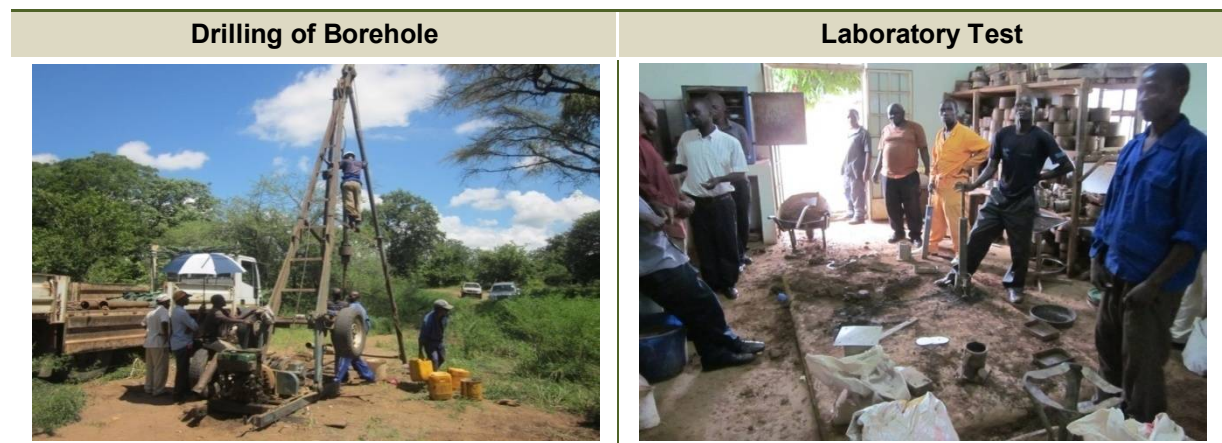
[Figure 3.5] Drilling of Borehole and Laboratory Test

- BH A Comprises of 2 layers and it was drilled to maximum of 2.65m.
- BH 1 Comprises of 6 layers and it was drilled to maximum of 6.47m.
- BH 2 Comprises of 6 layers and it was drilled to maximum of 6.5m.
- BH 3 Comprises of 3 layers and it was drilled to maximum of 9.70m.
- BH 4 & 5 were drilled to maximum of 2.235m on average.
- BH 7a Comprises of 3 layers and it was drilled to maximum of 1.30m.
- BH 6, 7 & 9 were drilled to maximum of 3.45m on average.
- BH 12, 13 & 14 were drilled to maximum of 4.15m on average.
- BH 15 & 16 were drilled to maximum of 3.45m each.
- BH 18 Comprises of 6 layers and it was drilled to maximum of 6.45m.
- BH 22 was drilled to maximum of 3.0m.
- BH 23 & 24 were drilled to maximum of 3.175m on average

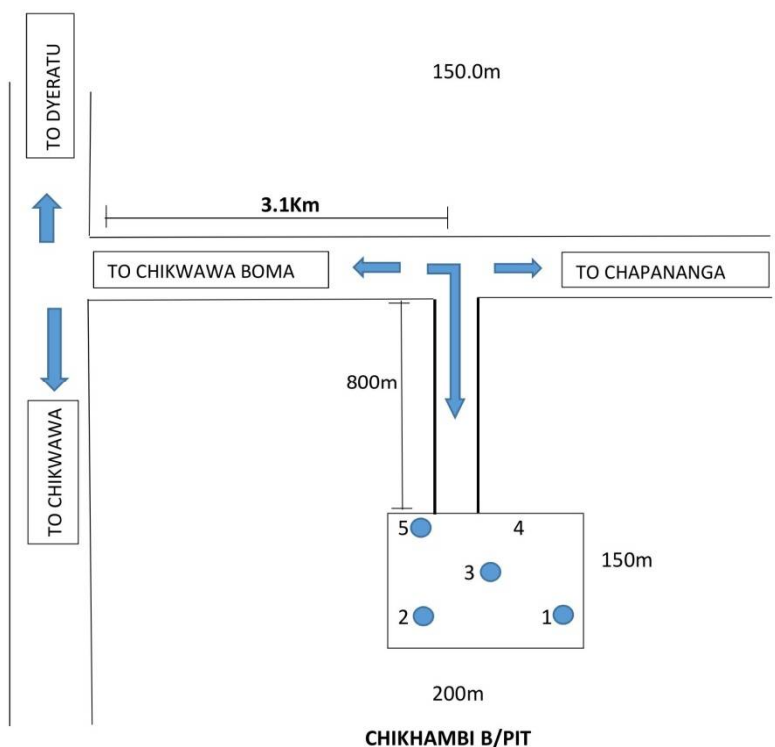
### CHIKHAMBI B/PIT

ESTIMATED AVAILABLE QUANTITY (NETT) (ALLOWING FOR 25% WASTAGE) =20,700m<sup>3</sup>
